Manhole Inspection Summary

Manhole # S39I__061MH

Insp Date: **7/9/08 11:54 AM**

Location Address: **217 Stiles St**

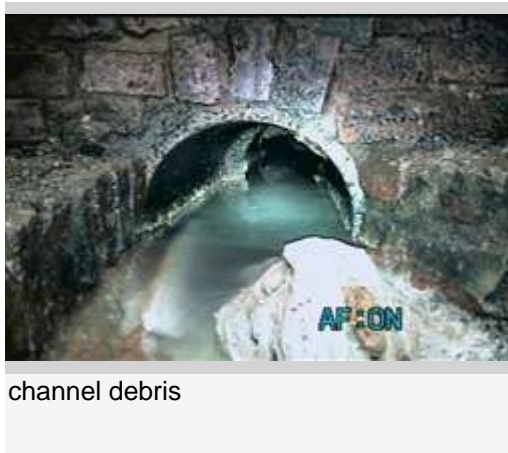
Defect 4

Condition: ☐ Sound ☐ Cracked ☐ Root Intrusion ☐ Deteriorated ☐ Leaks ☒ **Debris**

channel debris

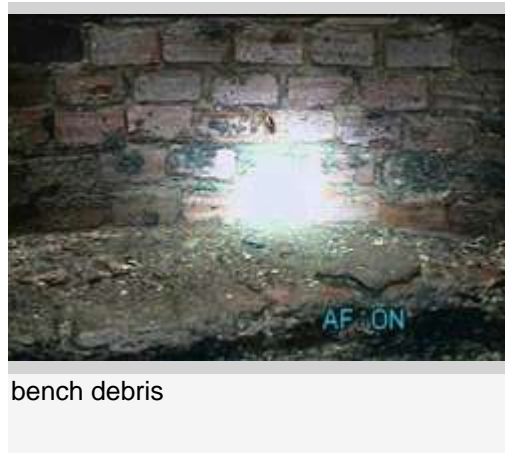
Defect 3

Condition: ☐ Sound ☐ Cracked ☐ Root Intrusion ☐ Deteriorated ☐ Leaks ☒ **Debris**

bench debris

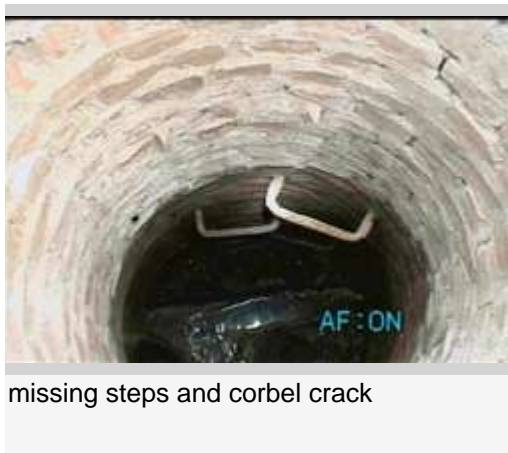
Defect 2

Condition: ☐ Sound ☒ **Cracked** ☐ Root Intrusion ☐ Loose Brick ☐ Deteriorated

Count: **6** Missing: **1** ☒ **Corroded**

missing steps and corbel crack

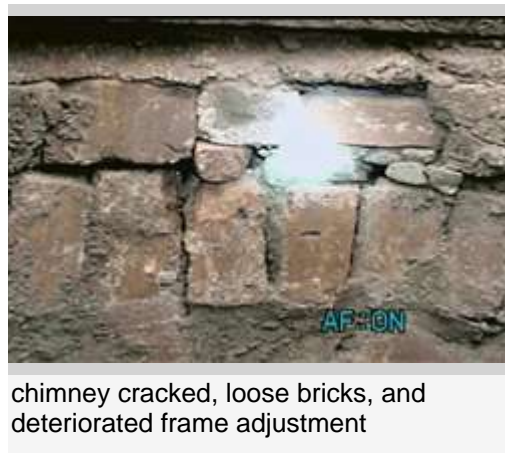
Defect 1

Condition: ☐ Sound ☒ **Cracked** ☐ Root Intrusion ☒ **Loose Brick** ☒ **Deteriorated**

chimney cracked, loose bricks, and deteriorated frame adjustment
